INDIANA UNIVERSITY

ON-SITE AMBULANCE CRASH INVESTIGATION

CASE NUMBER - IN11015

VEHICLE - 2010 CHEVROLET EXPRESS G4500 TYPE III AMBULANCE

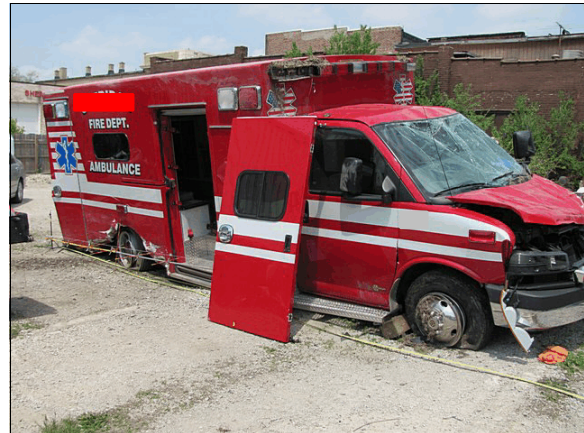
Figure 1: The damaged 2010 Chevrolet Express Type III ambulance

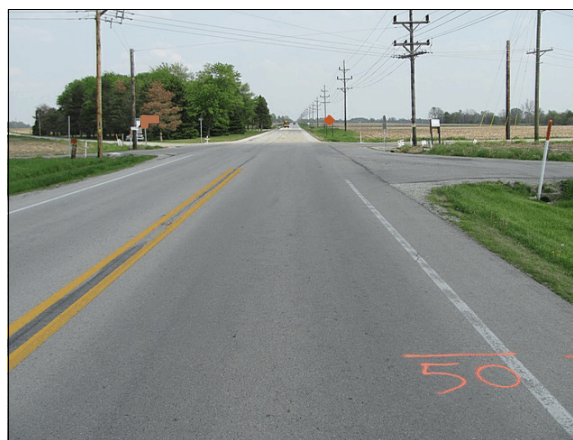
Pre-Crash: The ambulance was traveling southeast (**Figure 2**) and the driver intended to continue straight through the intersection. The

Figure 2: Approach of the ambulance southeast to the intersection, number indicates 50 m (164 ft) to impact area

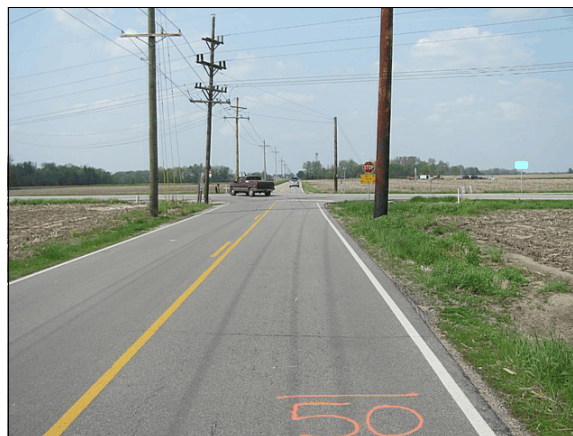
Chrysler was traveling north approaching the stop sign at the intersection (**Figure 3**). The driver of the Chrysler told police that she was not familiar with the roadway and did not see the stop sign as she approached the intersection. The driver of the ambulance stated during the SCI interview that he steered left to avoid the crash but did not have time to apply the brakes. The ambulance was equipped with an Event Data Recorder (EDR), which recorded 2.5 sec of pre-crash data. For each of the five pre-crash recording intervals, the EDR reported the ambulance traveling 100 km/h (62 mph) with the brake switch circuit reported as “Off.” Percent throttle was reported as 100% for the last two recording intervals.

Figure 3: Approach of the Chrysler northbound to the intersection; number indicates 50 m (164 ft) to impact area

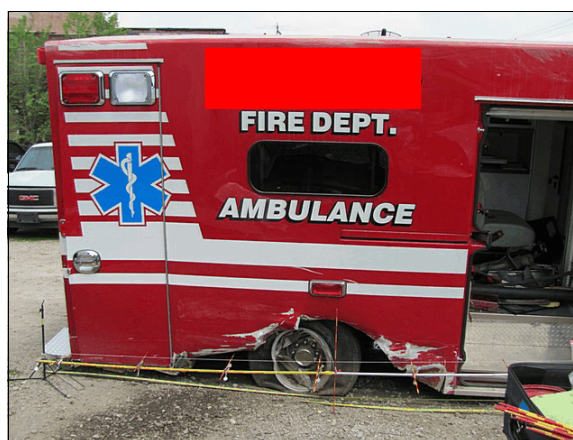
Crash: The right plane of the ambulance (**Figure 4**) was impacted by the front plane of the Chrysler (**Figure 5**, event 1). The force direction on the ambulance was within the 1 o’clock sector and the impact did not trigger deployment of the driver’s frontal air bag. The driver’s frontal air bag in the Chrysler deployed. The ambulance rotated clockwise 205 degrees as it traversed 32 m (105 ft) and departed the roadway (**Figure 6**). It rotated clockwise an additional 60 degrees as it traversed an additional 7 m (23 ft) and rolled over (event 2), right side leading, four quarter turns. The vehicle traversed a distance of 27 m (88.6 ft) during the rollover and came to final rest on its wheels heading east (**Figure 7**). The Chrysler rotated clockwise 120 degrees as it traversed 5.8 m (19 ft) and came to final rest within the intersection heading southeast.

Figure 4: Damage to the right plane of the ambulance from impact with the Chrysler

Exterior Damage, Event 1: The ambulance sustained right plane damage during the impact with the Chrysler. The direct damage resided on the right side of the patient compartment and began 132 cm (52 in) forward of the right rear axle extending 290 cm (114.2 in) rearward. The Field L was also 290 cm (114.2 in). The crush measurements were taken at the bottom of patient compartment and the maximum residual crush was 12 cm (4.7 in) occurring at C₃. The crush values were: C₁=0 cm, C₂= 0 cm, C₃=12 cm (4.7 in), C₄= 3 cm (1.2 in), C₅= 13 cm (5.1 in), C₆= 0 cm.

Damage Classification, Event 1: The Truck Deformation Classification (TDC) for the right plane impact was 01RBEWA. The WinSMASH reconstruction program could not be used to calculate a Delta V since heavy trucks are out of scope for the program. The System Status at Non-Deployment data block of the vehicle's EDR reported the maximum velocity change as 9.29 km/h (5.77 mph). The maximum longitudinal and lateral velocity changes reported on the EDR velocity change graphs were -6.57 km/h (-4.08 mph) and 5.75 km/h (3.57 mph), respectively.

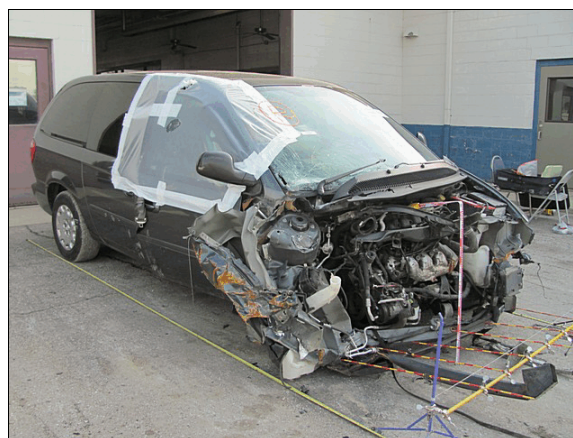
Figure 5: Front plane damage to the Chrysler from the impact with the ambulance

Exterior Damage: The Chrysler sustained front plane damage during the impact with the ambulance. The front bumper, grille, hood, both headlamp/turn signal assemblies, and the right fender sustained direct contact damage. The direct damage began at the front left bumper corner and extended 160 cm (63 in) across the full width of the front end. The Field L was 116 cm (45.7 in). Crush measurements were taken at the bumper level and the maximum residual crush was 54 cm (21.3 in) occurring at C₆. The crush values were: C₁=7 cm (2.8 in), C₂= 10 cm (3.9 in), C₃=31 cm (12.2 in), C₄= 45 cm (17.7 in), C₅= 46 cm (18.1 in), C₆= 54 cm (21.3 in).

Damage Classification: The CDC for the front plane damage was 10FDEW3 (300 degrees). Since the ambulance was an out of scope vehicle for the WinSMASH program, the Damage algorithm of WinSMASH was used to calculate a Barrier Equivalent Speed (BES) for the Chrysler. The calculated BES was 28 km/h (17.4 mph).

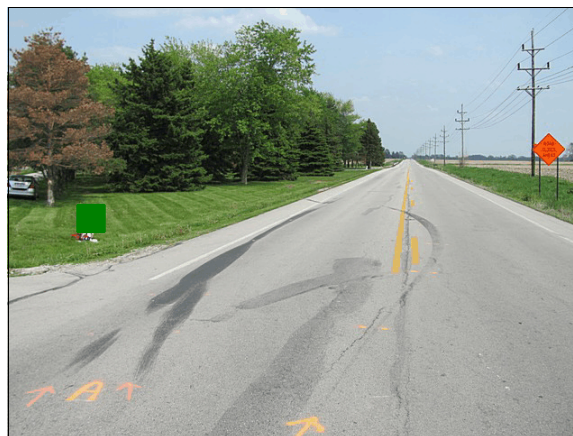
Figure 6: Post-impact travel of the ambulance southeast to left side road departure

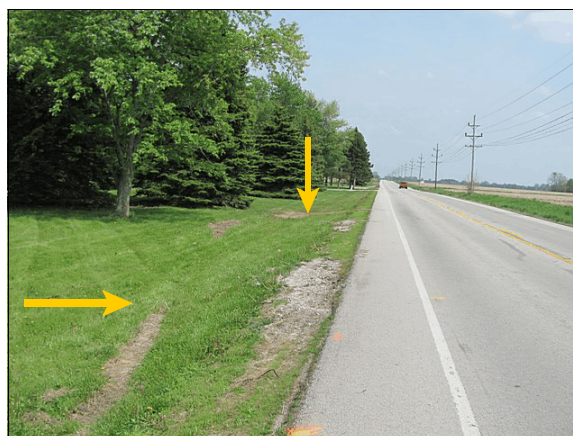
Figure 7: View southeast to the trip point of the ambulance (arrow in foreground); arrow in background shows location of final rest of the ambulance

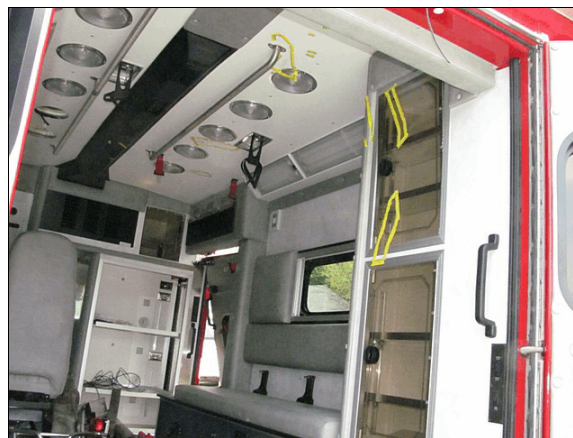
There were contact marks on the back right medical supply cabinet and roof of the patient compartment from contact by the displaced patient cot (**Figures 8 and 9**). The four areas of contact on the roof were located 58 cm (22.8 in), 100 cm (39.4 in), 208 in (81.9 in), and 263 cm (103.5 in) forward of the patient loading doors and approximately 67 cm (26.4 in) from the right wall of the patient compartment. There were also several possible occupant contact marks from the EMT on the ventilation duct on the roof.

Figure 8: Yellow tape shows contact scuff marks from the displaced patient cot

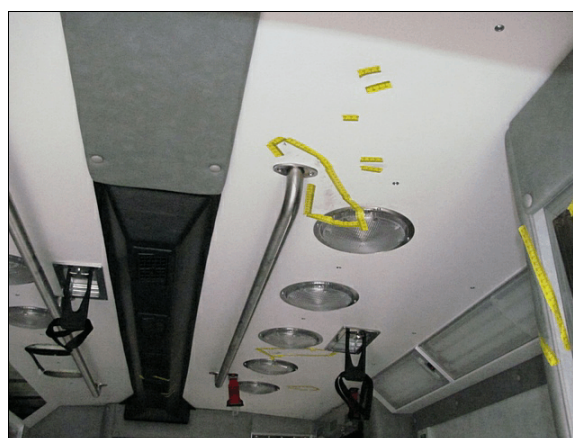
Figure 9: Closer view of contact marks on the roof from the displaced patient cot

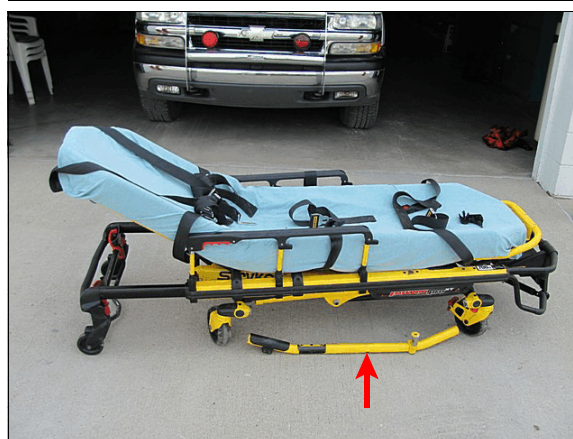
Patient Cot: The cot that was used to transport the patient was a Stryker 6500 Power Pro XT (**Figure 10**), serial number 060240005. The cot was an aluminum X-frame design and its maximum weight capacity was 318 kg (700 lbs). It was equipped with a 24 volt battery hydraulic lift system. The standard length and width was 206 cm (81 in) and 58 cm (23 in), respectively. Its lowest adjustable position was 36 cm (14 in) and the highest was 105 cm (41 in). The cot was equipped with two torso restraints, two shoulder straps, and leg restraints. The ambulance driver stated during the SCI interview that the patient was secured on the cot by the torso and leg restraints. The shoulder straps were not used. She was facing rearward and her head/upper torso was elevated approximately 32 degrees.

Figure 10: The Stryker 6500 Power Pro XT patient cot; arrow shows the separated rail clamp frame

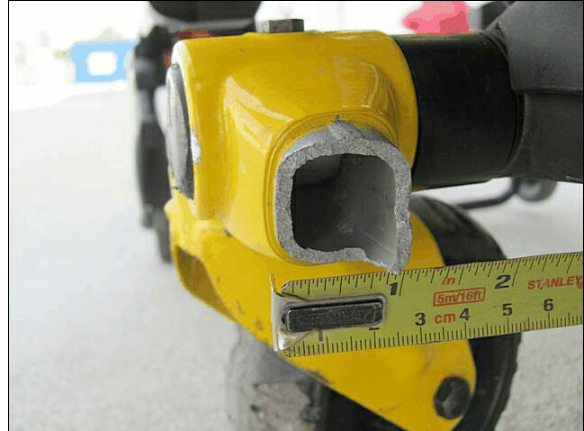
2 mm (0.08 in), while the wall thickness of the inner tube was approximately 4 mm (0.2 in). The length of the broken rail clamp frame was 84 cm (33.1 in). The foot end of the rail clamp frame (**Figure 13**) was bent laterally approximately 6.4 cm (2.5 in). The lower right lift bar on the foot end of the cot was also fractured and bent forward 9 cm (3.5 in). The battery was separated from the cot.

Figure 11: The fracture site of the rail clamp frame at the head end of the patient cot

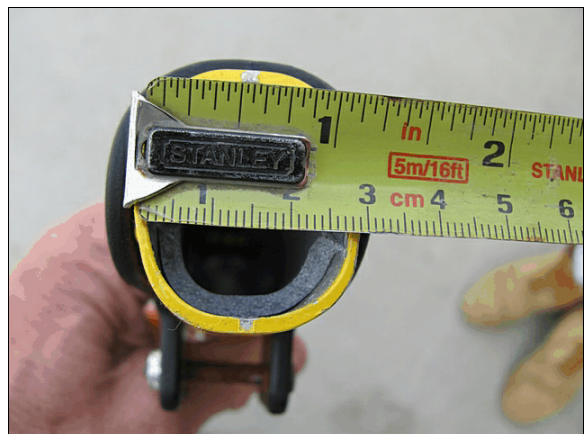
Figure 12: The fracture site on the head end of rail clamp frame

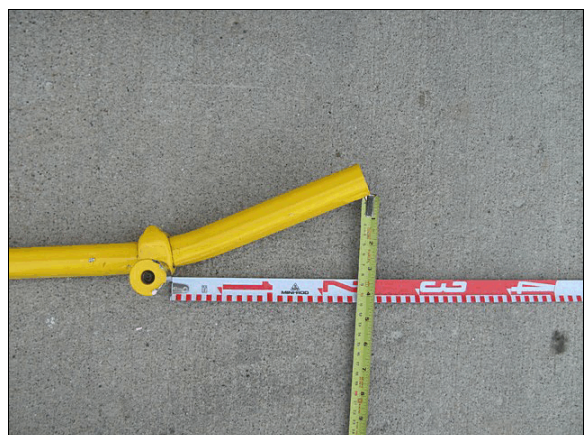
Figure 13: The bent foot end of the rail clamp frame

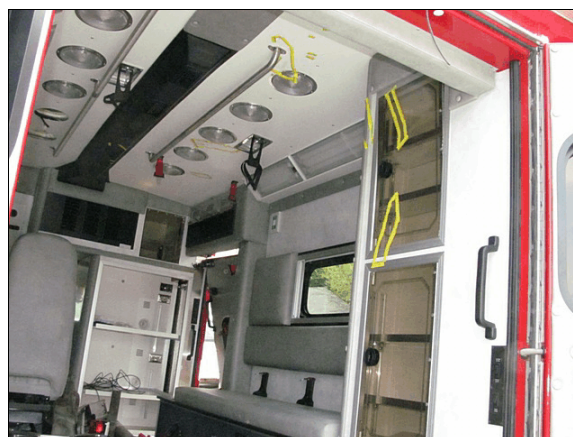
Figure 14: Yellow tape shows contact marks from patient cot on right side supply cabinet and roof

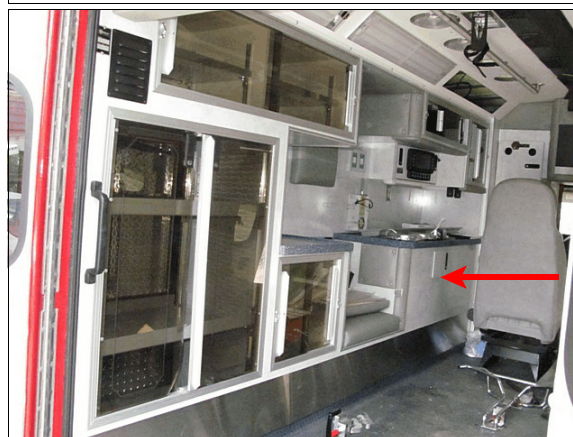
Figure 15: Arrow shows area of probably patient contact to EMT work area; the patient came to final rest face down on the floor between the EMT work area and the rail clamp with the cot on top of her

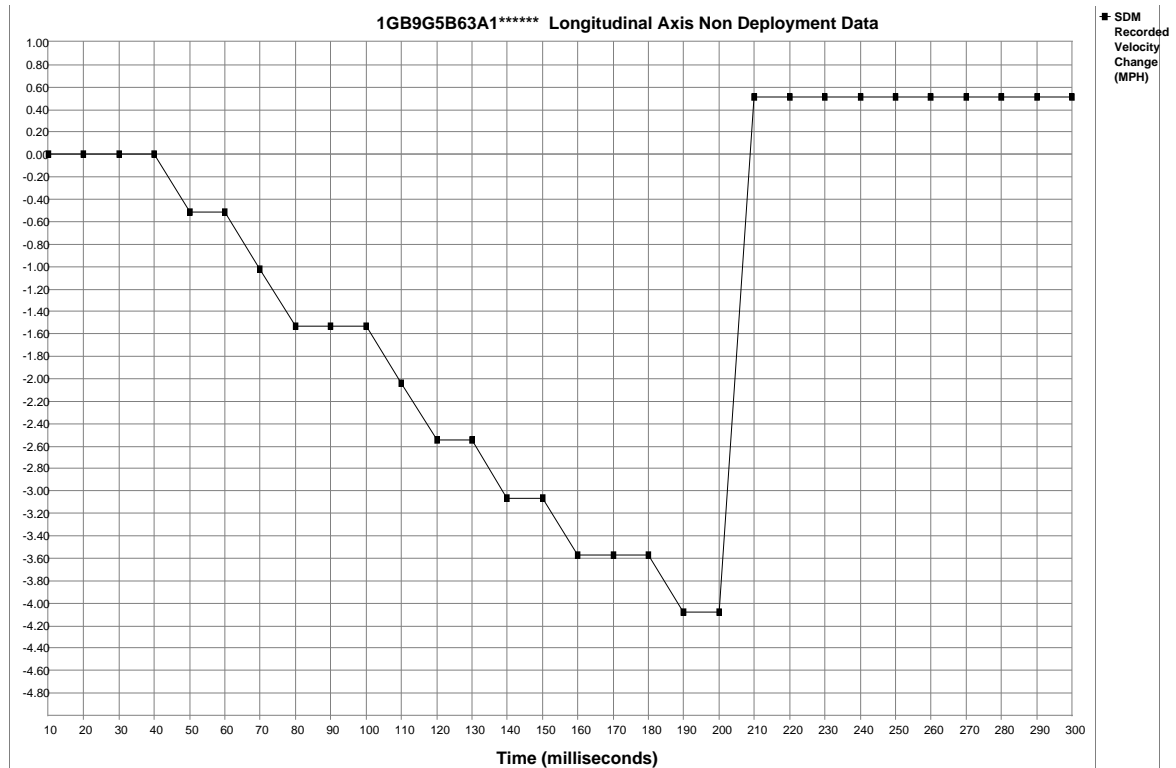
Time (milliseconds)	10	20	30	40	50	60	70	80	90	100	110	120	130	140	150
SDM Longitudinal Axis Recorded Velocity Change (MPH)	0.00	0.00	0.00	0.00	-0.51	-0.51	-1.02	-1.53	-1.53	-1.53	-2.04	-2.55	-2.55	-3.06	-3.06
Time (milliseconds)	160	170	180	190	200	210	220	230	240	250	260	270	280	290	300
SDM Longitudinal Axis Recorded Velocity Change (MPH)	-3.57	-3.57	-3.57	-4.08	-4.08	0.51	0.51	0.51	0.51	0.51	0.51	0.51	0.51	0.51	0.51

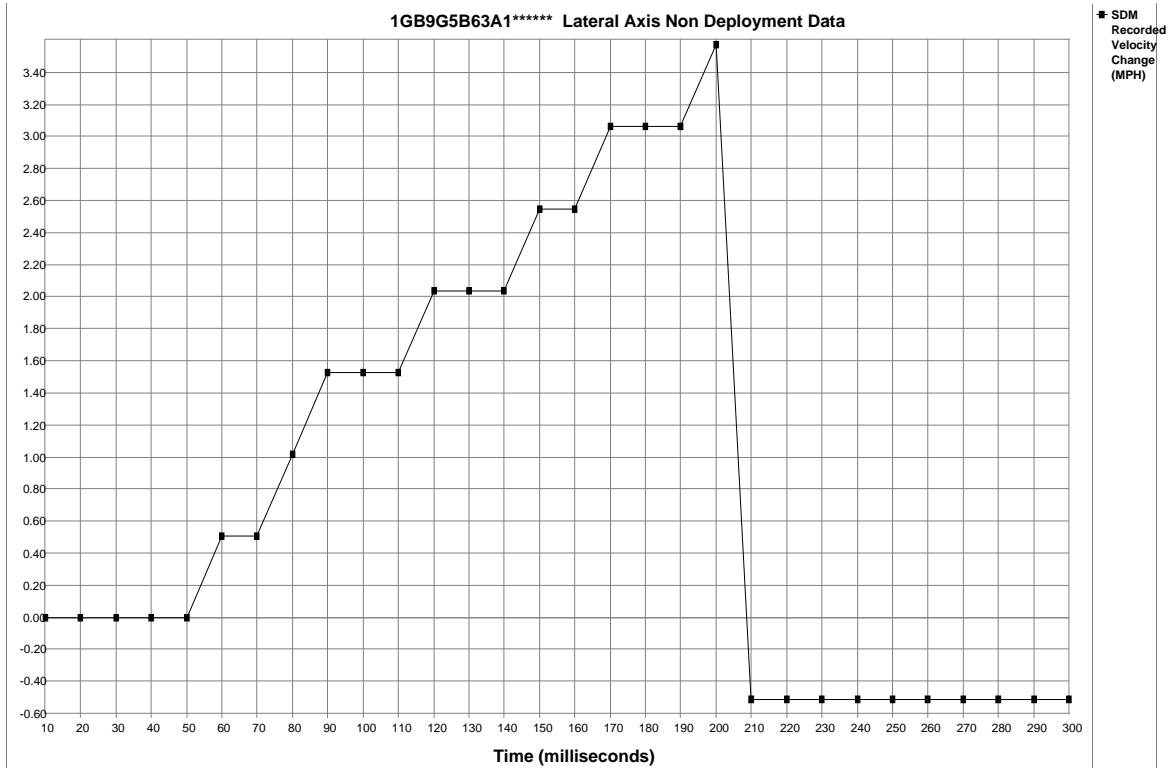
Time (milliseconds)	10	20	30	40	50	60	70	80	90	100	110	120	130	140	150
SDM Lateral Axis Recorded Velocity Change (MPH)	0.00	0.00	0.00	0.00	0.00	0.51	0.51	1.02	1.53	1.53	1.53	2.04	2.04	2.04	2.55
Time (milliseconds)	160	170	180	190	200	210	220	230	240	250	260	270	280	290	300
SDM Lateral Axis Recorded Velocity Change (MPH)	2.55	3.06	3.06	3.06	3.57	-0.51	-0.51	-0.51	-0.51	-0.51	-0.51	-0.51	-0.51	-0.51	-0.51
